Manhole Inspection Summary

Manhole # S31QQ_017MH

Insp Date: **4/30/07 9:59 AM**

Location Address: **2656 27TH ST**

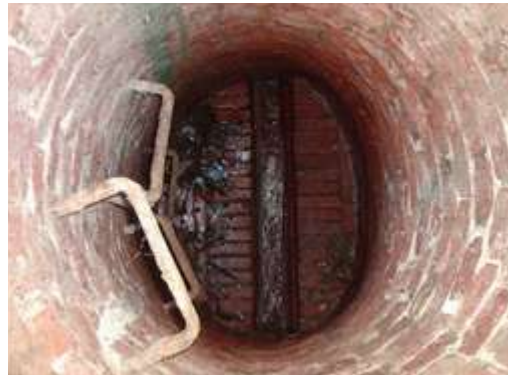
Top View

Corroded steps. Bench debris.

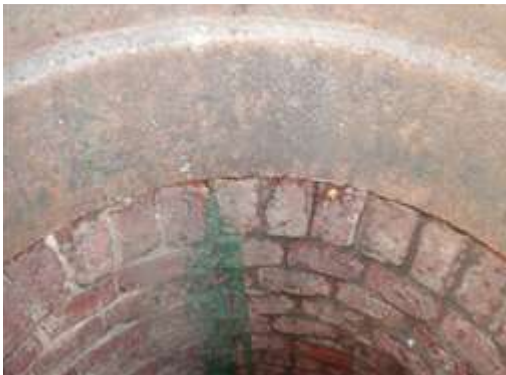
Defect

☒ **Leaks**

Condition: ☐ Sound ☐ Cracked ☐ Root Intrusion ☐ Loose Brick ☒ **Deteriorated**

Infiltration: ☐ None ☒ **Joint** ☐ Cracks ☐ Mortar ☐ Roots ☒ **Wall**

Infiltration: ☐ None ☐ Joint ☐ Cracks ☐ Mortar ☐ Roots ☒ **Wall**

Frame leaks. Adjustment deterioration and infiltration. Corbel infiltration.

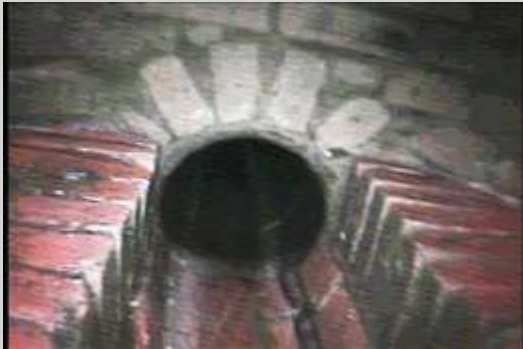
8 in. Circular Gravity Sewer Pipe Out @ 12 O'Clock

Bench deterioration.

Infiltration: **Evidence** Pipe Seal Cond: **Unknown**
